REPORT OF
SUBSURFACE EXPLORATION, FIELD INFILTRATION TESTING AND
GEOTECHNICAL ENGINEERING ANALYSIS
HAMPTON INN & SUITES
BAIR BOULEVARD
NEW STANTON BOROUGH, WESTMORELAND COUNTY, PENNSYLVANIA

ECS PROJECT NO. 40:1547

Subsurface Exploration, Field Infiltration Testing and
Geotechnical Engineering Analysis
Hampton Inn & Suites
New Stanton Borough, Westmoreland County, Pennsylvania

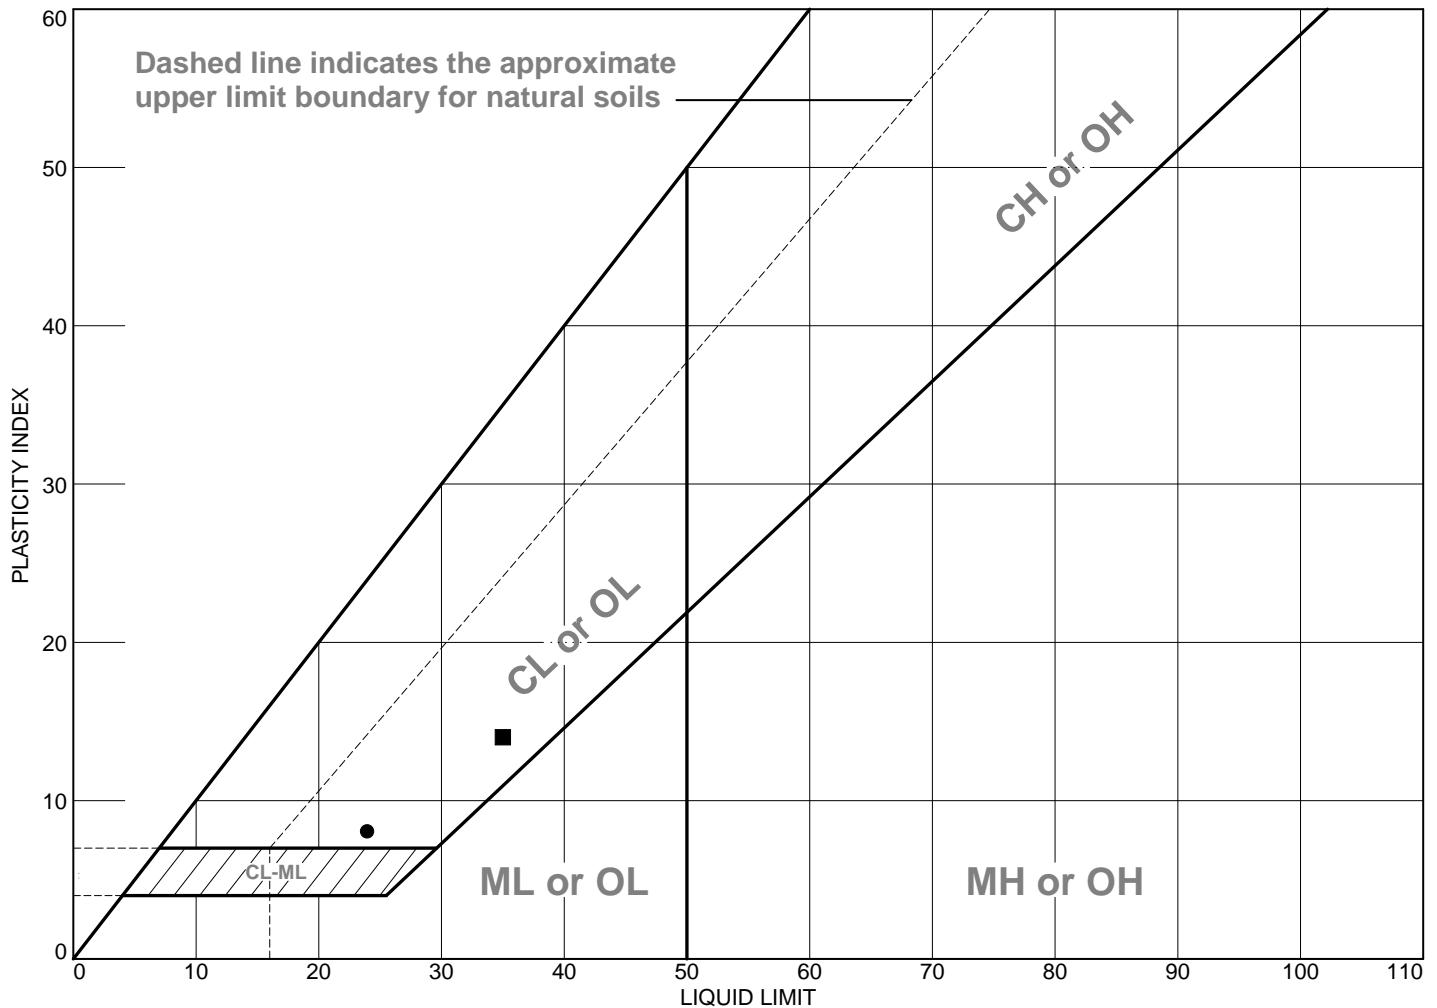
LIQUID AND PLASTIC LIMITS TEST REPORT

| | MATERIAL DESCRIPTION | LL | PL | PI | %<#40 | %<#200 | USCS |
|---|--|---|---|---|---|---|---|
| ● | (SC FILL) CLAYEY SAND, Trace Rock Fragments, Brown and Dark Brown, Moist, Very Loose | 24 | 16 | 8 | NV | 39.0 | SC |

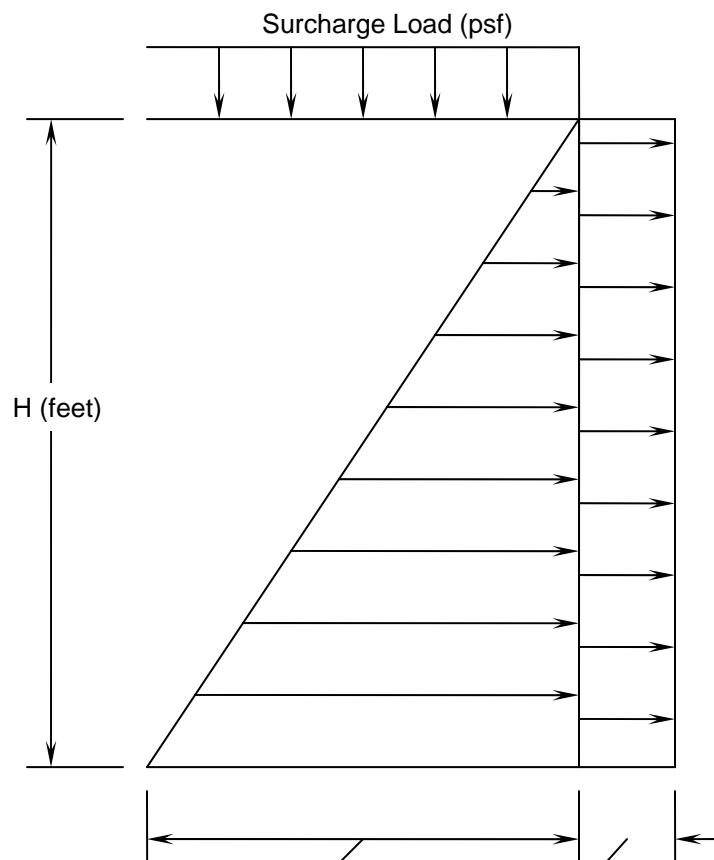
LATERAL EARTH PRESSURE DIAGRAM
(DRAINED CONDITION) – SPREAD FOOTINGS

Lateral Earth Pressure = $60 H$ psf
(For below grade walls restrained from movement
at top and bottom, drained conditions presumed)

Horizontal Pressure from Surcharge
= $0.5 \times$ Vertical Surcharge

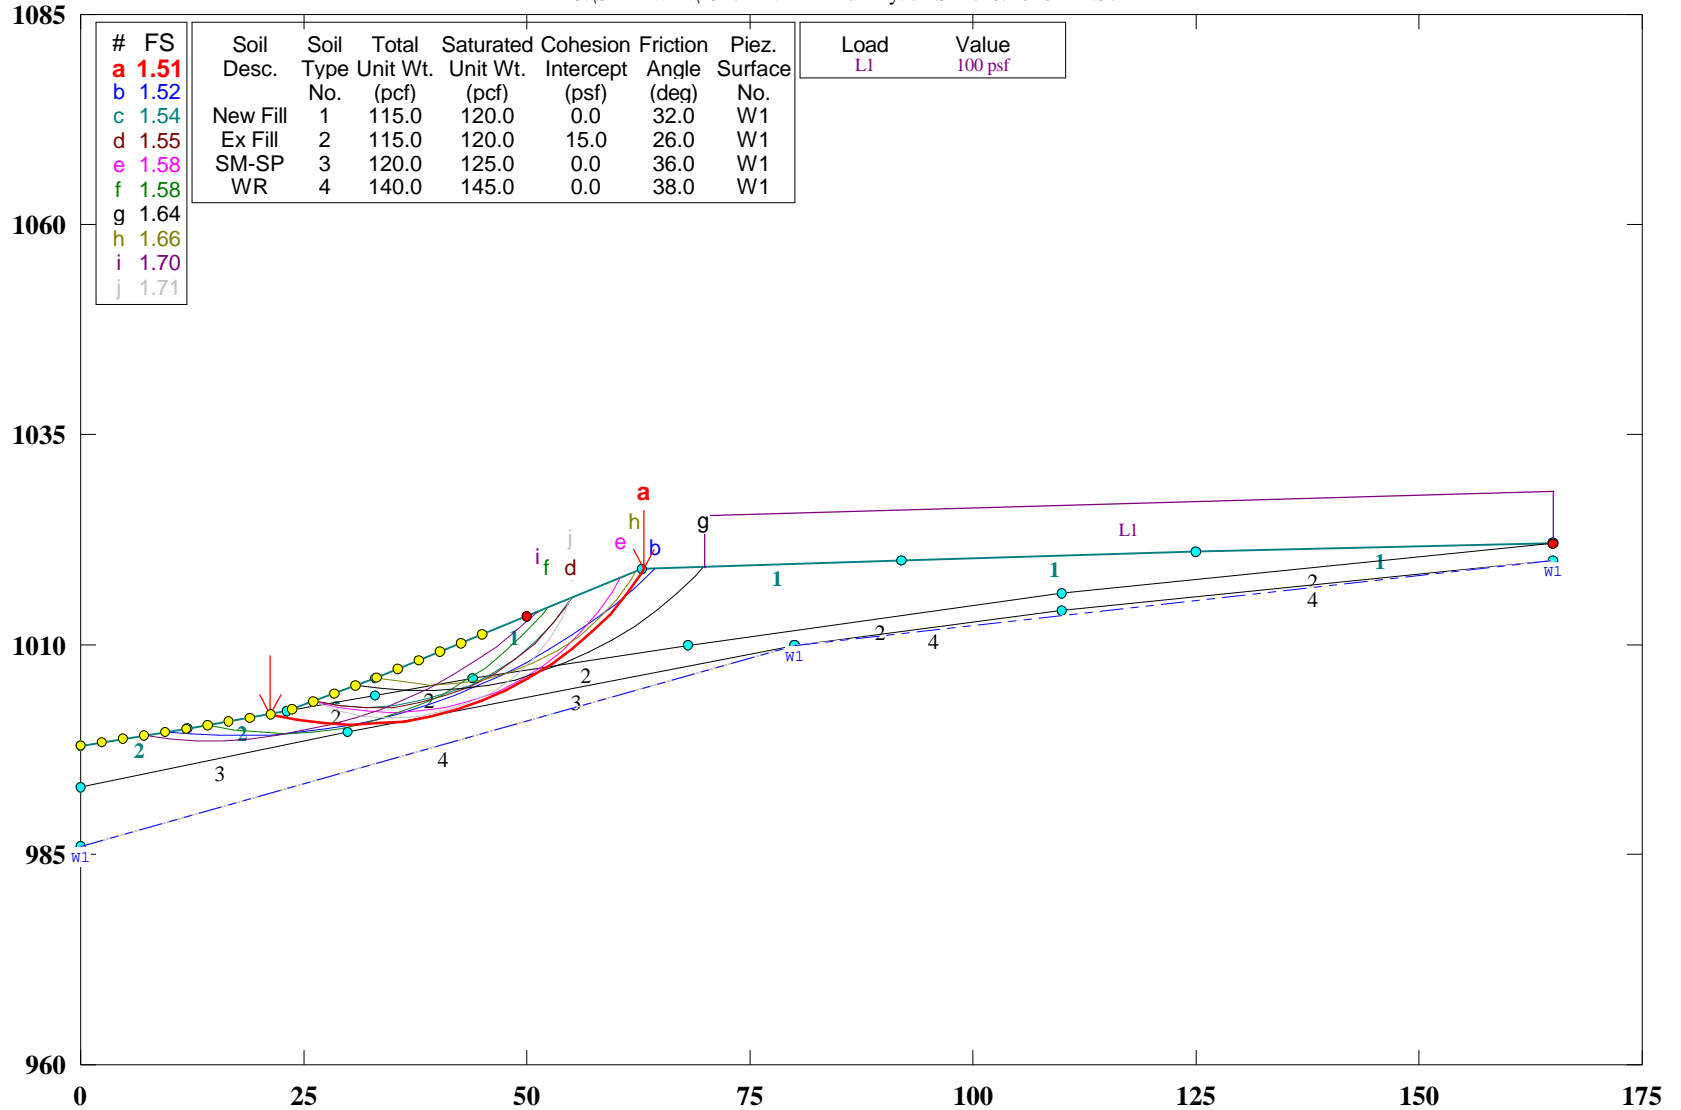
Hampton Inn and Suites Section A-A

GSTABL7 FSmin=1.51

Safety Factors Are Calculated By The Modified Bishop Method

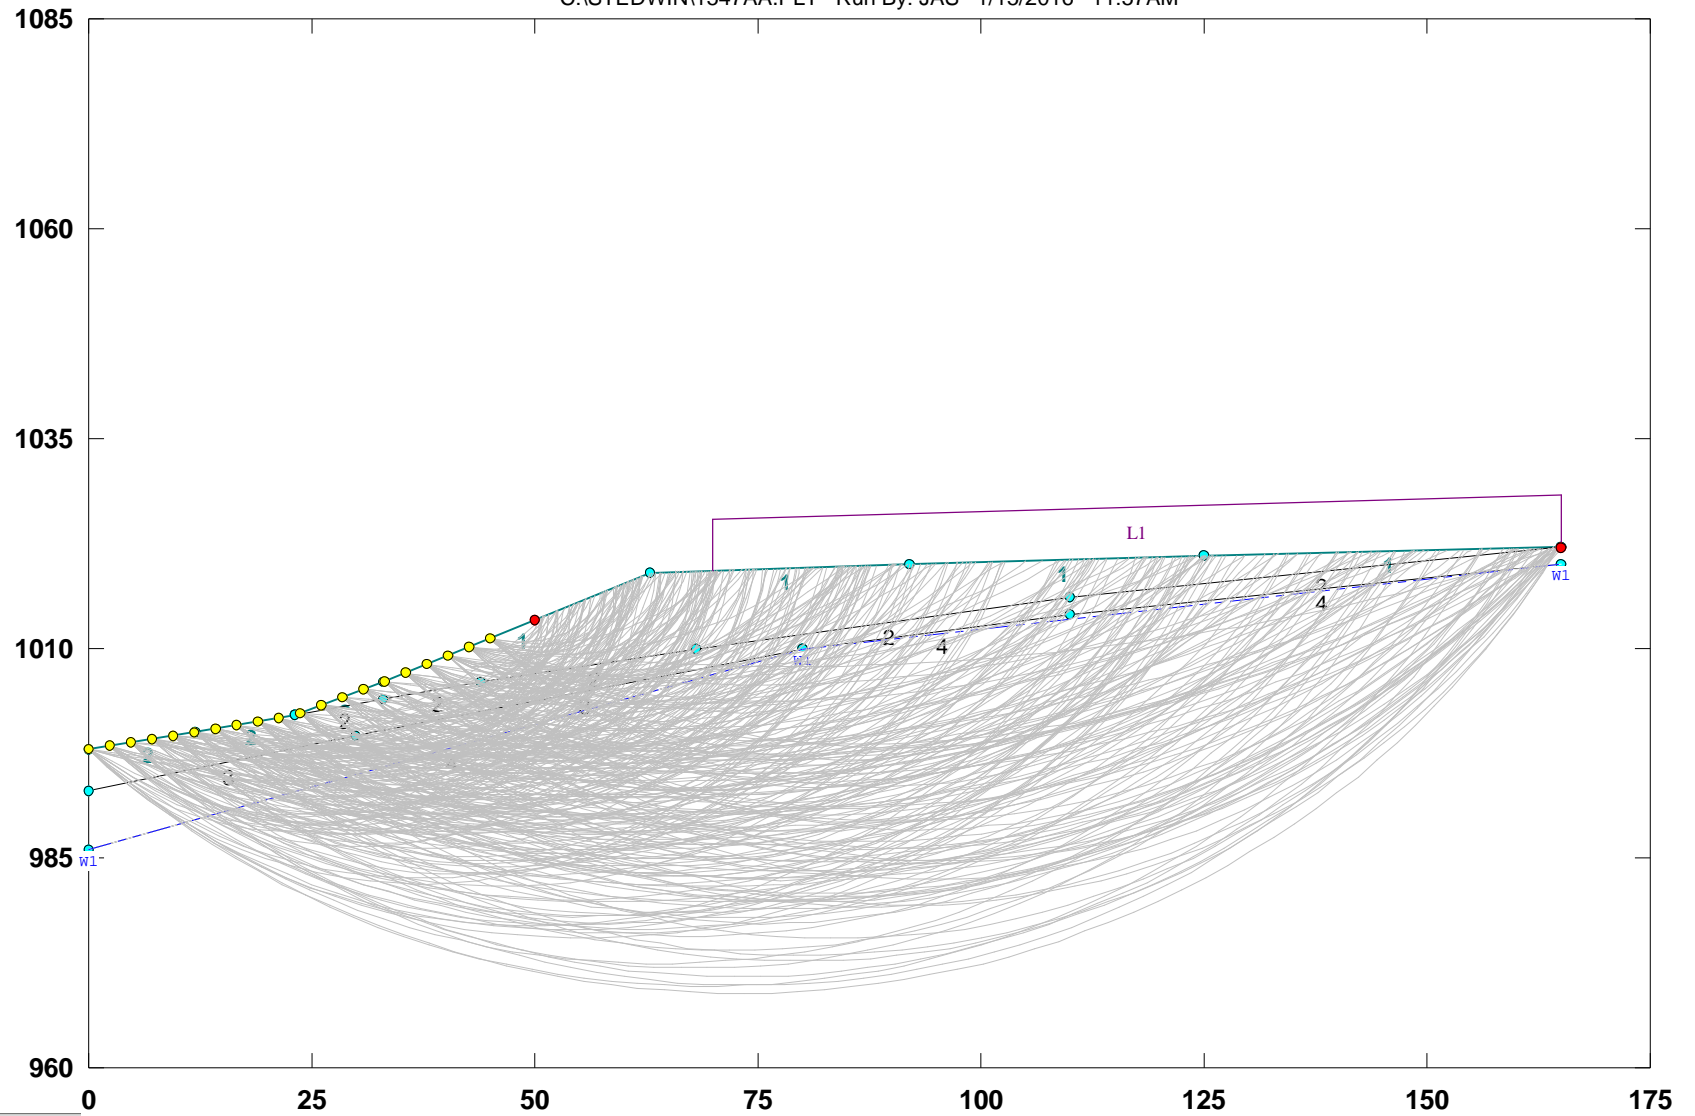
Hampton Inn and Suites Section A-A

*** GSTABL7 ***
